## Damages

# Objective of this Presentation. Expand specialised knowledge.

The objective of this presentation is to indicate the essentials in the **maintenance, service and repair of safety valves.**

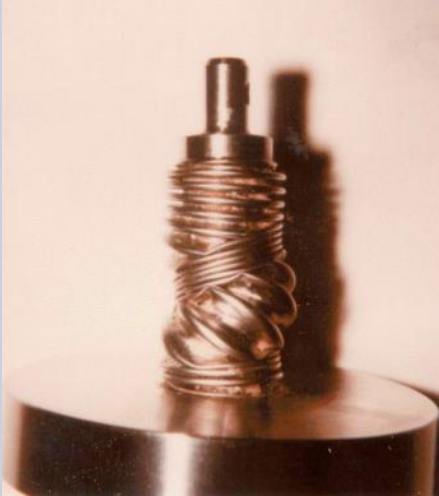
Situation	Fault / Technical background	LESER Solution
<ul style="list-style-type: none"><li>▪ Bent stainless steel bellows</li></ul>

<p>➔</p> <ul style="list-style-type: none"><li>▪ The valve doesn't work</li><li>▪ Bellows was damaged during assembly/disassembly</li></ul>	<p>➔</p> <ul style="list-style-type: none"><li>▪ Follow the LESER maintenance and service instructions</li></ul>

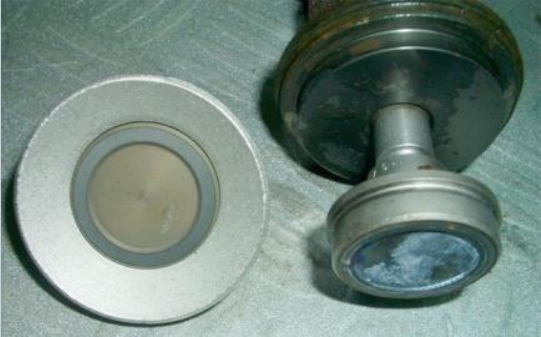
Situation	Fault / Technical background	LESER Solution
<p>When lapping the disc, the lifting aid got in the way and was twisted off</p>

<ul style="list-style-type: none"><li>▪ Perfect functioning of the valve is no longer possible</li><li>▪ The performance of the valve cannot be achieved in the stipulated limits</li></ul>	<ul style="list-style-type: none"><li>▪ Use the matching lapping stamps</li><li>▪ Use a removeable lifting aid</li></ul>

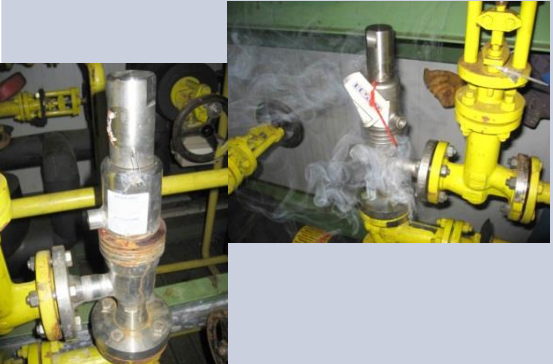
Situation	Fault / Technical background	LESER Solution
<ul style="list-style-type: none"><li>A conventional safety valve was subsequently equipped with stainless steel bellows by a specialised workshop</li></ul>

<ul style="list-style-type: none"><li>The valve is no longer gas-tight</li><li>Poisonous medium escapes between the bonnet and bonnet spacer</li></ul>	<ul style="list-style-type: none"><li>During the modification, it is mandatory to use new seals and not to forget any seals</li></ul>

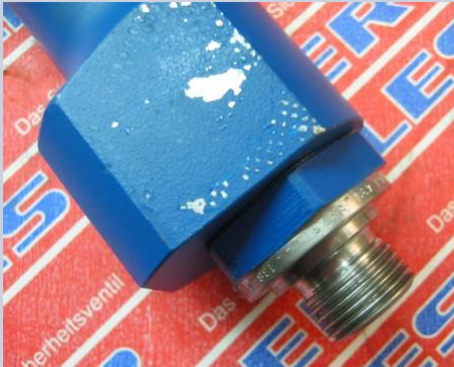
Situation	Fault / Technical background	LESER Solution
<ul style="list-style-type: none"><li>The threaded valve is mounted on the inlet and outlet piping. Afterwards, the safety valve is leaky.</li></ul>

<ul style="list-style-type: none"><li>Slip-joint pliers were used on the valve body to install the valve and align it with the pipelines.</li></ul>	<ul style="list-style-type: none"><li>It is absolutely necessary to only use the appropriate spanner on the hexagonal collar.</li></ul>

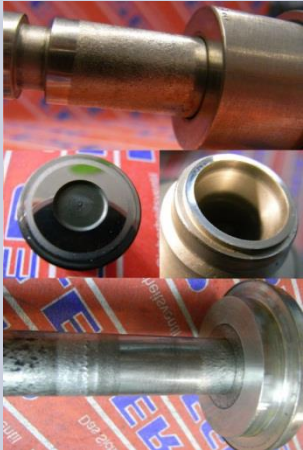
Situation	Fault / Technical background	LESER Solution
<ul style="list-style-type: none"><li>▪ The safety valve knocks</li><li>▪ The safety valve is leaky as a result.</li></ul>

<ul style="list-style-type: none"><li>▪ Due to the long lasting knocking of the safety valve, the surface of the seat and disc were damaged</li><li>▪ The spindle is damaged near the guide</li></ul>	<ul style="list-style-type: none"><li>▪ Check the design of the safety valve</li><li>▪ Check the design of the supply and discharge lines</li><li>▪ Use an O-ring damper</li></ul>

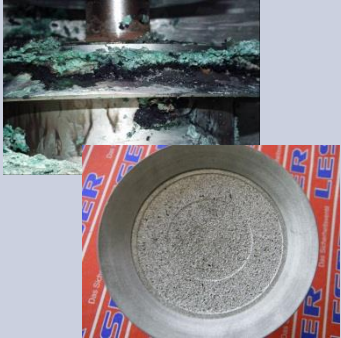
Situation	Fault / Technical background	LESER Solution
<ul style="list-style-type: none"><li>▪ The vessel to be protected contains corrosive medium</li><li>▪ A safety valve made of a low-alloy carbon steel is installed for protection, which is not suitable for this application</li></ul>

<p>Hastelloy when HCL is used</p>

<ul style="list-style-type: none"><li>▪ The safety valve becomes leaky during the operating phase.</li><li>▪ The corrosion resistance of the seatings is not guaranteed. The surfaces are destroyed by the corrosion</li></ul>

<ul style="list-style-type: none"><li>▪ Use high-alloy material for the parts that are in contact with the medium (seat/disc)</li><li>▪ The other parts of the safety valve can still be made of the standard material, as the valve rarely opens.</li></ul>

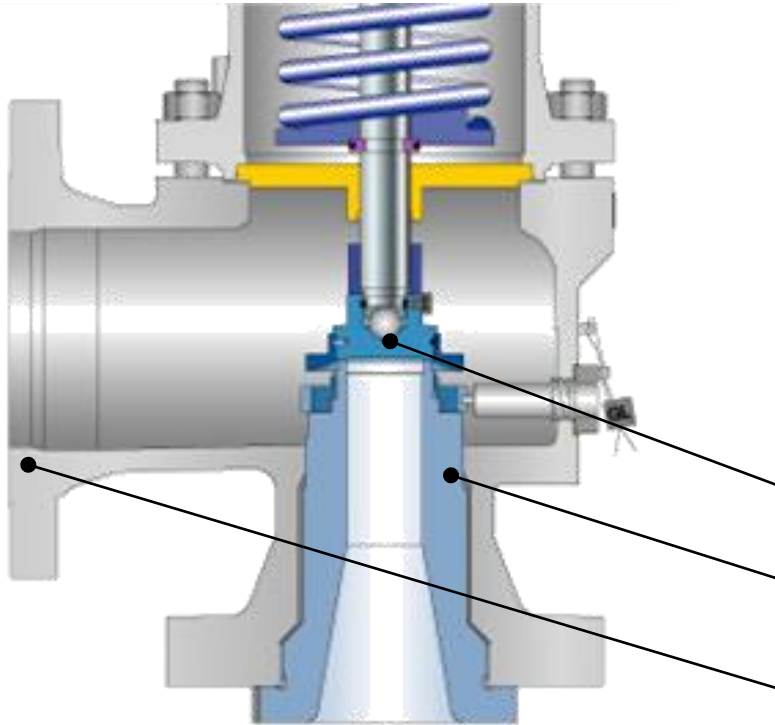
# Installation Situation. Example of special material type 526.

## Special materials:

- Hastelloy®
- Zirconium
- Tantalum
- Titanium
- Monel®
- Inconel®

Disc

Nozzle

Body

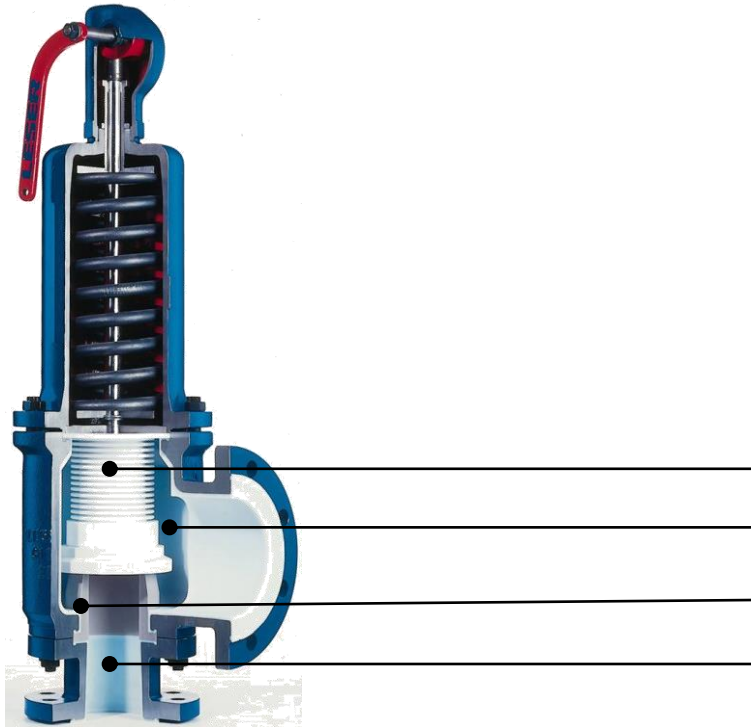
# Installation Situation. Example of special material type 447.

## Use:

- Used if the corrosion resistance of austenitic or highly-alloyed metallic materials is inadequate.
- Chemicals industry
- Highly corrosive and aggressive fluids
- Universal use
- Viscose fluids

PTFE bellows

Outlet body, PTFE lined

Nozzle, PTFE/glass component

Inlet body, PTFE lined

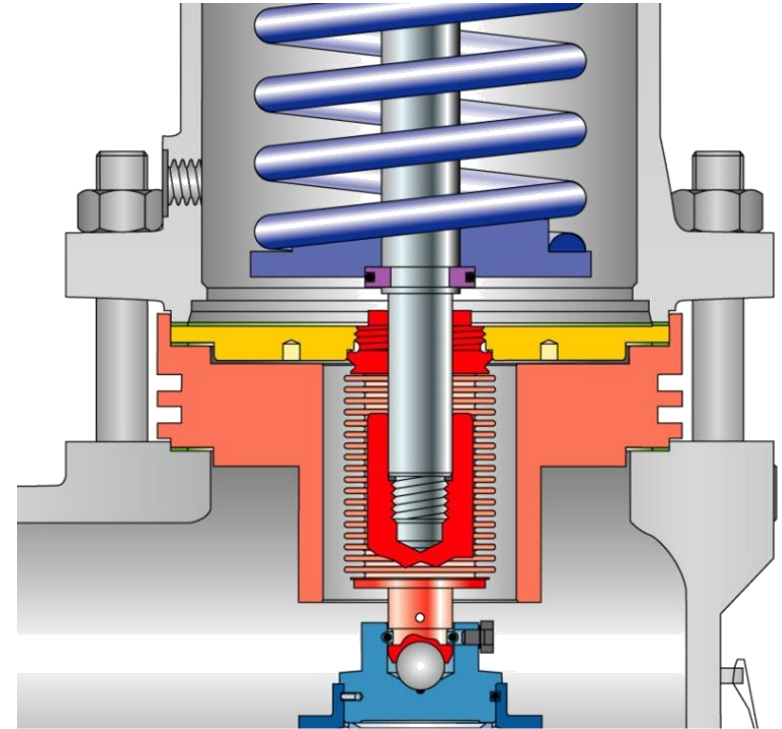
## Properties:

- Protects moving parts and the spring against dirt, corrosion, impurities, temperatures and the medium itself.
- Standard material  
1.4571/1.4404 (316 SS)

Situation	Fault / Technical background	LESER Solution
<ul style="list-style-type: none"><li>The medium is dirty</li></ul>	<ul style="list-style-type: none"><li>The spindle / guide may be blocked</li></ul>

<ul style="list-style-type: none"><li>Stainless steel bellows should be used</li></ul>

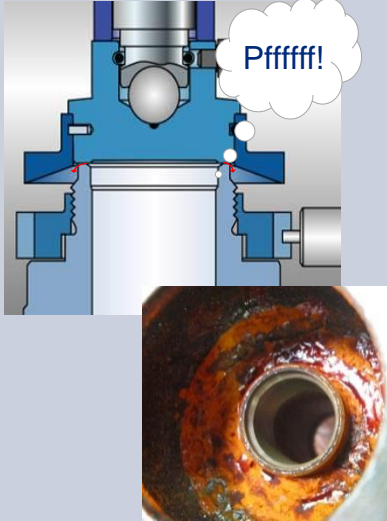
Situation	Fault / Technical background	LESER Solution
<ul style="list-style-type: none"><li>The medium contains particles</li></ul>	<ul style="list-style-type: none"><li>After blowing out, the safety valve no longer meets the seal tightness requirements.</li><li>Particles remain stuck to the surface of the seat after blowing out.</li></ul>

<p>Pffffff!</p> <ul style="list-style-type: none"><li>By using a soft seal, it is possible to compensate for minor damage to the surface.</li></ul>

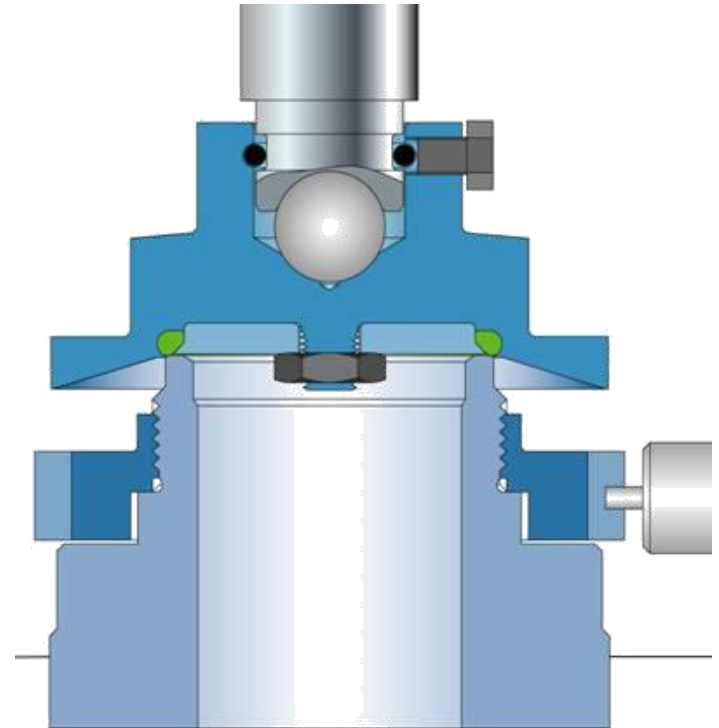
## Properties:

- Increased seal tightness
- Compensation for minor damage to seat
- Different elastomer materials are available (CR, NBR, EPDM, FPM, FKM, FFKM)
- Vacuum-tight
- Lasting seal tightness even after repeated opening

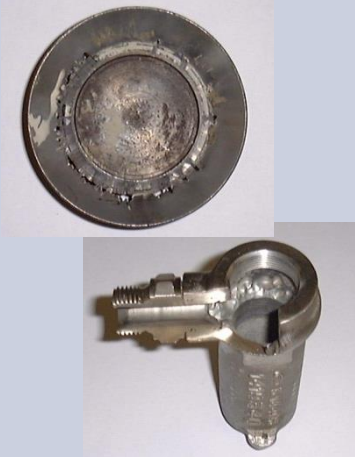
Situation	Fault / Technical background	LESER Solution
<ul style="list-style-type: none"><li>▪ The safety valve leaks</li><li>▪ The medium is aggressive</li></ul>

<p>→</p> <ul style="list-style-type: none"><li>▪ Seat and top disc surface eroding</li><li>▪ Operating pressure too close to set pressure</li></ul>	<p>→</p> <ul style="list-style-type: none"><li>▪ The difference between the operating pressure and set pressure must be more than 10% to prevent a leak.</li></ul>

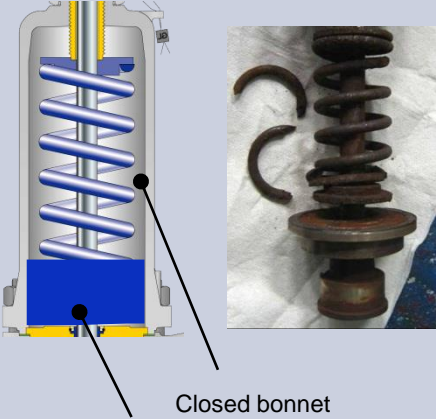
Situation	Fault / Technical background	LESER Solution
<ul style="list-style-type: none"><li>▪ The valve is open and can no longer be closed.</li><li>▪ The system must be switched off.</li></ul>	<p>→</p> <ul style="list-style-type: none"><li>▪ The spring was damaged by fluid in the bonnet.</li></ul>

<p>Closed bonnet</p> <p>Medium (e.g. water) cannot flow out.</p>	<p>→</p> <ul style="list-style-type: none"><li>▪ The bonnet and body should be emptied using a drainage hole.</li><li>▪ The outlet piping should also be given a drainage hole.</li></ul>

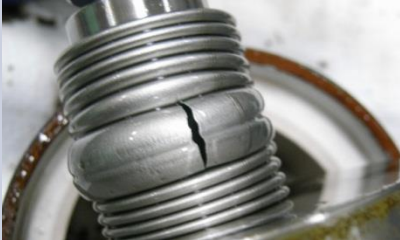
Situation	Fault / Technical background	LESER Solution
<ul style="list-style-type: none"><li>▪ The safety valve is connected to an outdoor system</li></ul>	<ul style="list-style-type: none"><li>▪ Condensed water or other fluids have collected in the stainless steel bellows.</li><li>▪ In frosty conditions, the fluid in the bellows froze.</li><li>▪ The spring chamber monitor is not connected.</li></ul>

<ul style="list-style-type: none"><li>▪ Connection of a suitable bonnet vent piping which prevents the intrusion of moisture.</li></ul>

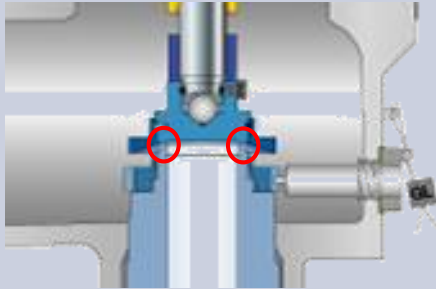
Situation	Fault / Technical background	LESER Solution
<ul style="list-style-type: none"><li>▪ The temperature of the leaking medium is higher than 450°C.</li></ul>	<p>→</p> <ul style="list-style-type: none"><li>▪ The safety valve begins to leak. The seal tightness requirements are no longer fulfilled.</li><li>▪ The disc material is not suitable for temperatures above 450°C. The surface may deform, resulting in a leak.</li></ul>

<ul style="list-style-type: none"><li>▪ For applications with temperatures above 450°C, use a stellite sealing surface.</li></ul>

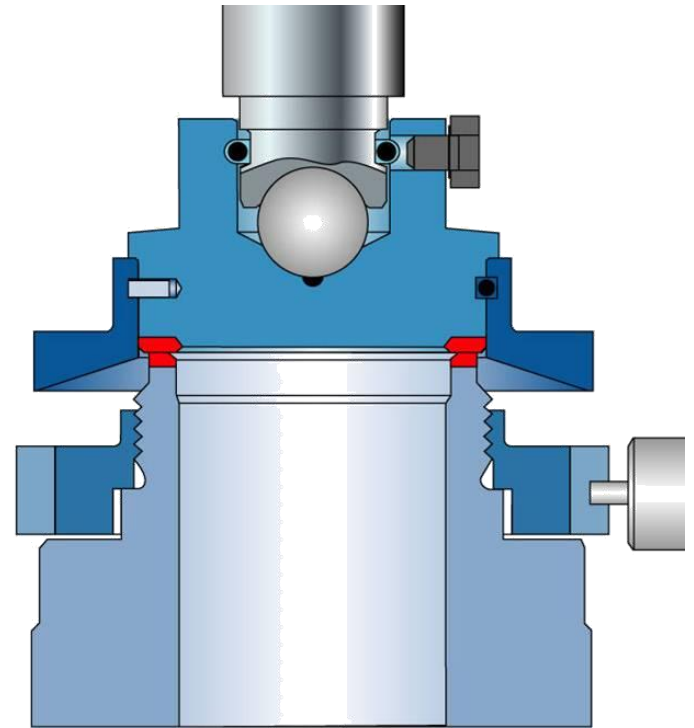
## Properties:

- Suitable for temperatures above 450°C. Protection of the sealing surface against aggressive media
- Stellite seatings of the disc, seat, and/or nozzle

## Advantages:

- Anti-corrosion protection
- Resistant to the effects and changing temperatures.

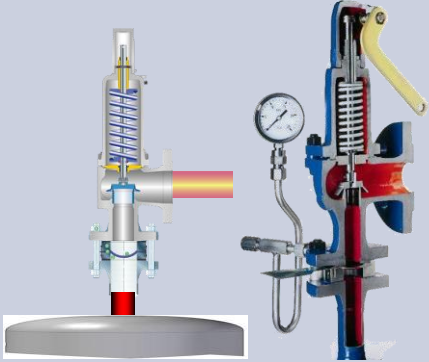
Situation	Fault / Technical background	LESER Solution
<ul style="list-style-type: none"><li>Absolute seal tightness regarding corrosion or poisonous media</li></ul>	<p>→</p> <ul style="list-style-type: none"><li>The leak rate of the safety valve is too high. Absolute seal tightness cannot be assured.</li></ul> <p>→</p>

<p>The image shows two components: on the left, a safety valve with a blue and silver body and a red stem; on the right, a bursting disc assembly with a blue and red body and a yellow handle. A pressure gauge is attached to the bursting disc assembly.</p> <ul style="list-style-type: none"><li>Combination of safety valve and bursting disc</li><li>Both pressure units fulfil the requirements of the National Board</li></ul>
